İMA AKADEMİ YAYINLARI NU.3

12 Temmuz 2020 tarihinde USS BONHOMME RICHARD (LHD – 6)'da meydana gelen yangında Sabit AFFF sisteminin incelenmesi

USS Navy'nin 12 Eylül 2021 tarihli "COMMAND INVESTIGATION INTO THE FACTS AND CIRCUMSTANCES SURROUNDING THE FIRE ONBOARD USS BONHOMME RICHARD (LHD 6) ON OR ABOUT 12 JULY 2020" adlı raporu

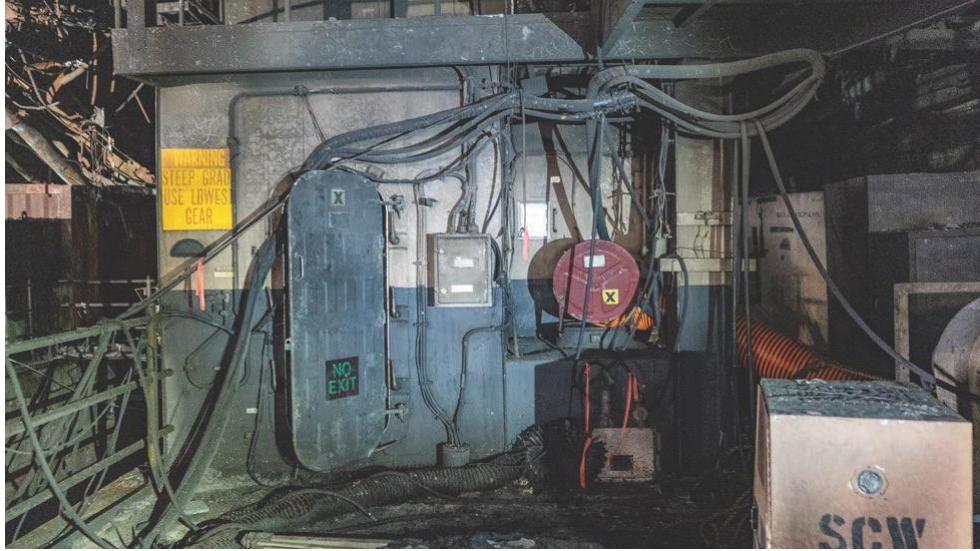
Resim – 3 Alt V güverteye hizmet veren 15 ve 16 sprinkler grupları için AFFF basmalı butonlarının fotoğrafı (solda 16; sağda 15). Bu basmalı butonlar, gemi ortasında Üst V' güvertededir. Açık bir kaporta, basma düğmelerinin görünürlüğünü engellemektedir.⁷⁸

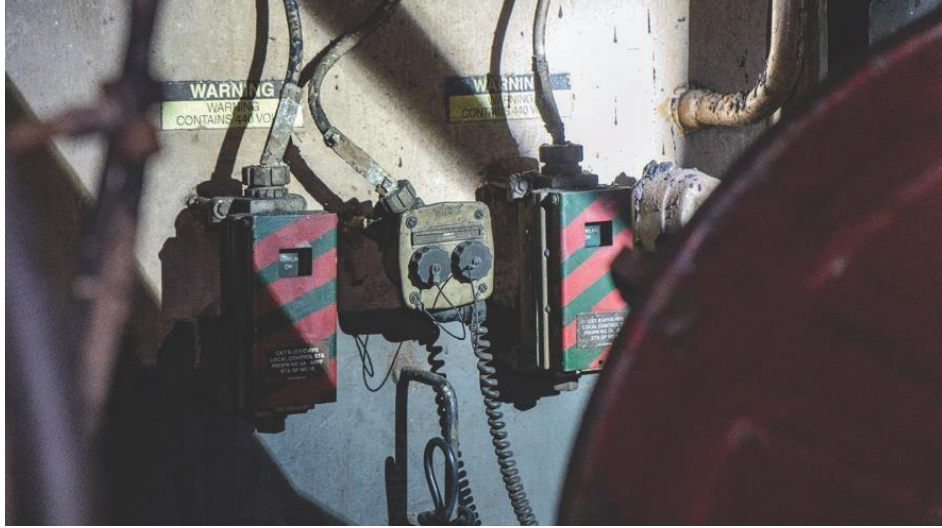
Resim – 4 Kapakları kapalı (solda 16; sağda 15) Alt V güverteye hizmet veren sprinkler grupları 15 ve 16 için AFFF butonlarının fotoğrafı. Bu basmalı butonlar, gemi ortasında Üst V güvertededir.⁷⁹

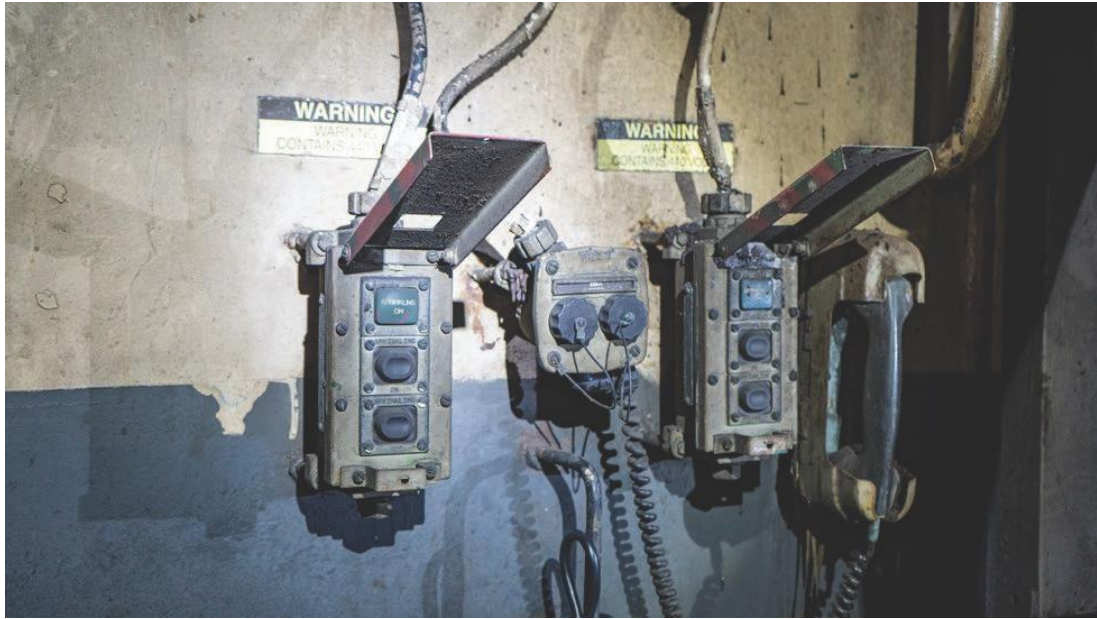
Resim – 5 Kapakları açık (solda 16; sağda 15) Alt V güverteye hizmet veren sprinkler grupları 15 ve 16 için AFFF butonlarının fotoğrafı. Bu basmalı butonlar, gemi ortasında Üst V güvertededir.⁸⁰

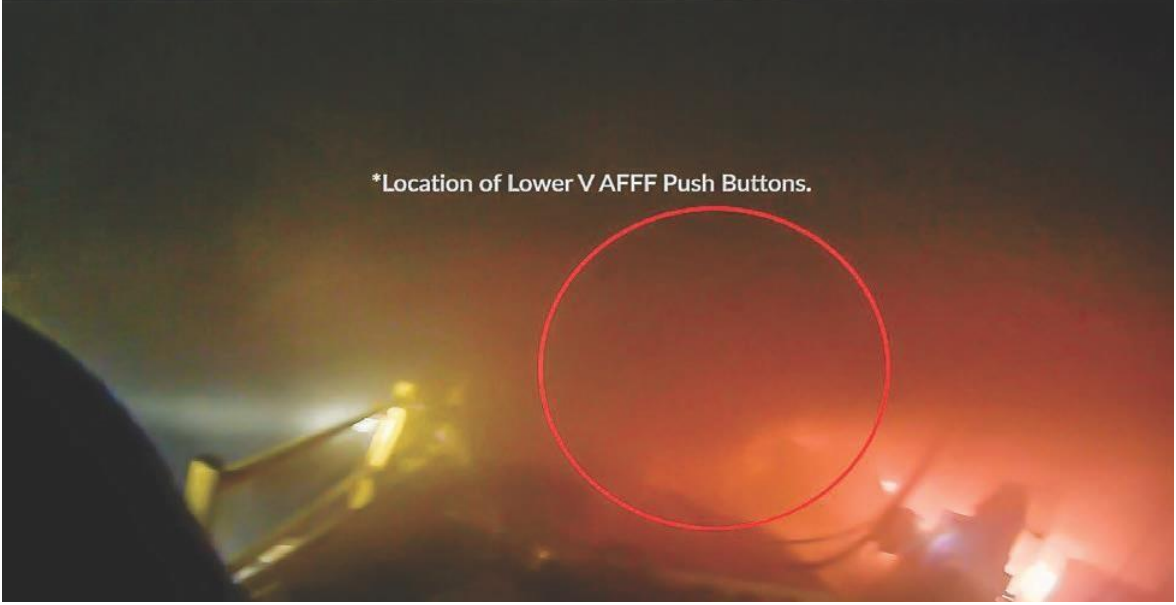
Şekil 6, San Diego İtfaiye Departmanı (SDFD) tarafından sağlanan GoPro videosundan alınan fotoğraf, SDFD'nin yan iskele üzerinden araç depolama alanına girmesinden sonra 12 Temmuz 2020'de AFFF butonlarının yerini gösteriyor.⁸¹

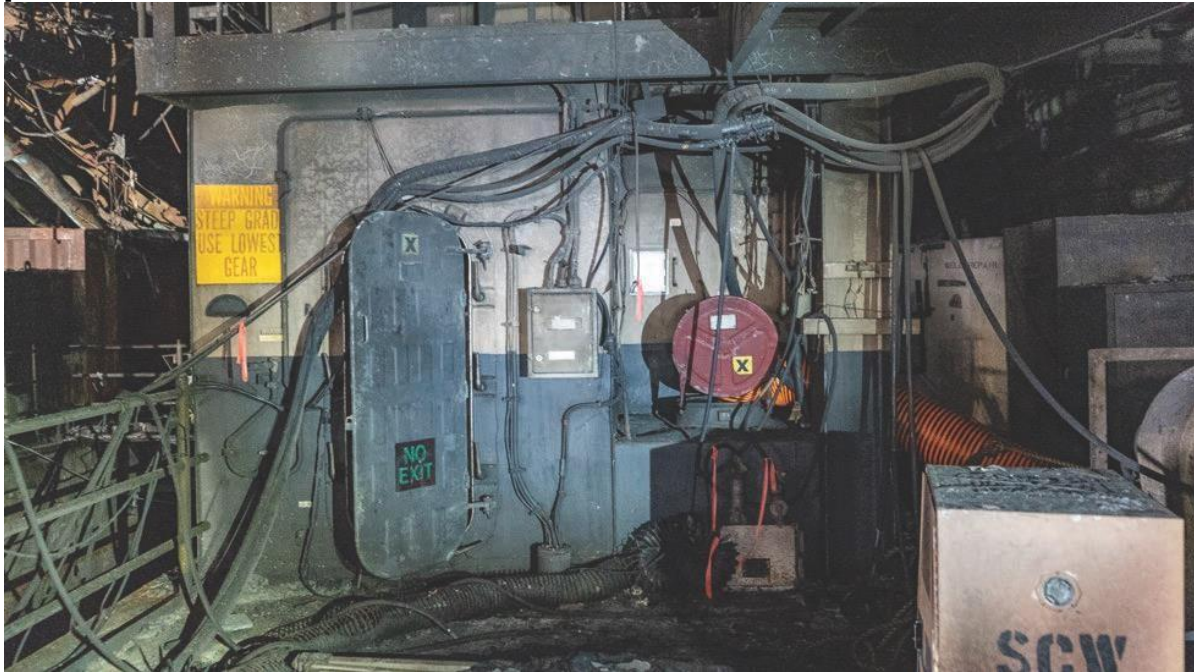
⁷⁸ Figure 29, Still photo of AFFF push-buttons for sprinkler groups 15 and 16 serving Lower V (16 on left; 15 on right). These push-buttons are in Upper V amidships. An open hatch obstructs visibility of the push-buttons.

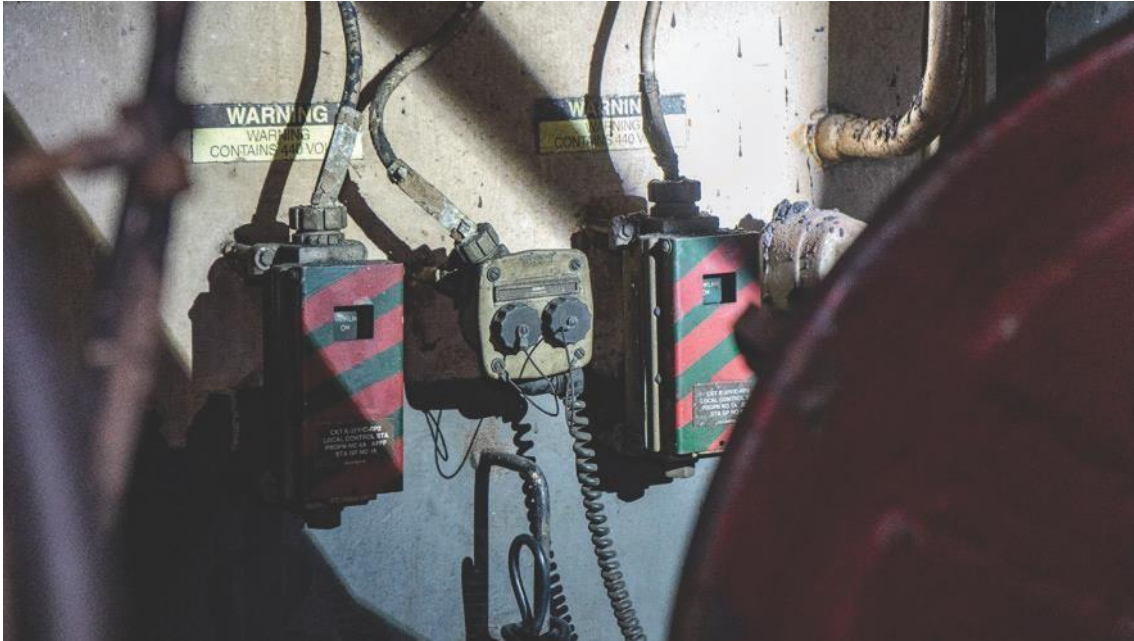
⁷⁹ Figure 30, Still photo of AFFF push-buttons for sprinkler groups 15 and 16 serving Lower V with covers closed (16 on left; 15 on right). These push-buttons are in Upper V amidships. The photo shows proximity to open hatch, which obstructs visibility of the push

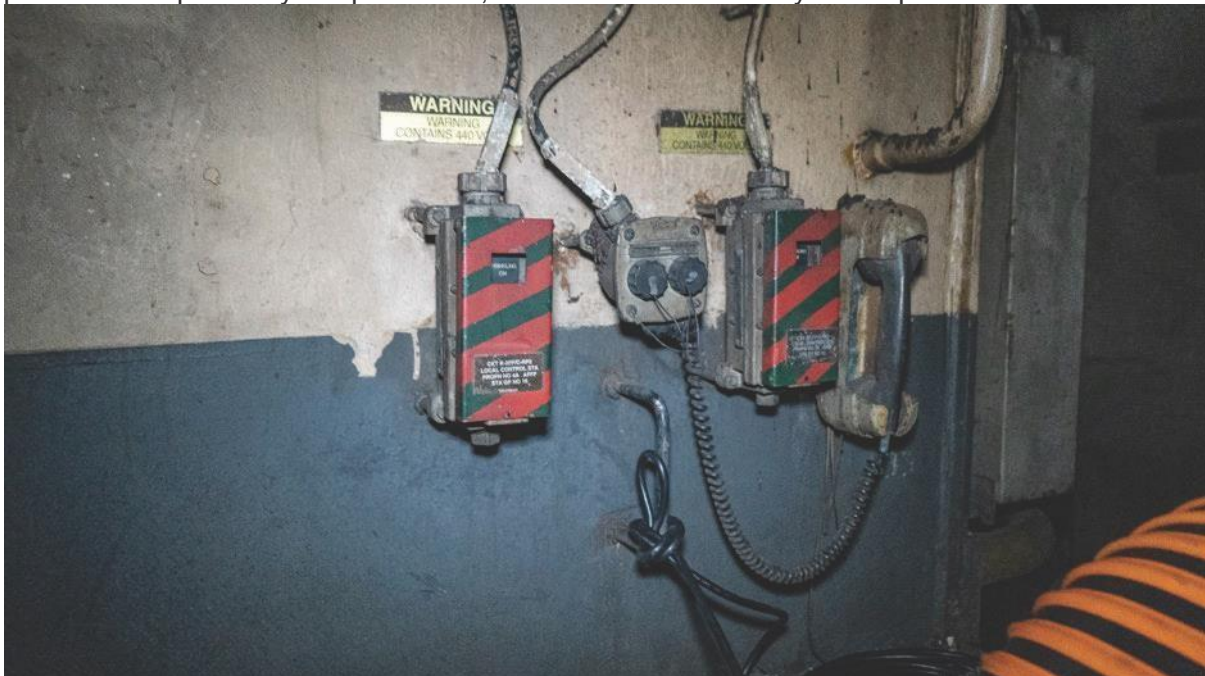
, Still photo of AFFF push-buttons for sprinkler groups 15 and 16 serving Lower V with covers closed (16 on left; 15 on right). These push-buttons are in Upper V amidships.

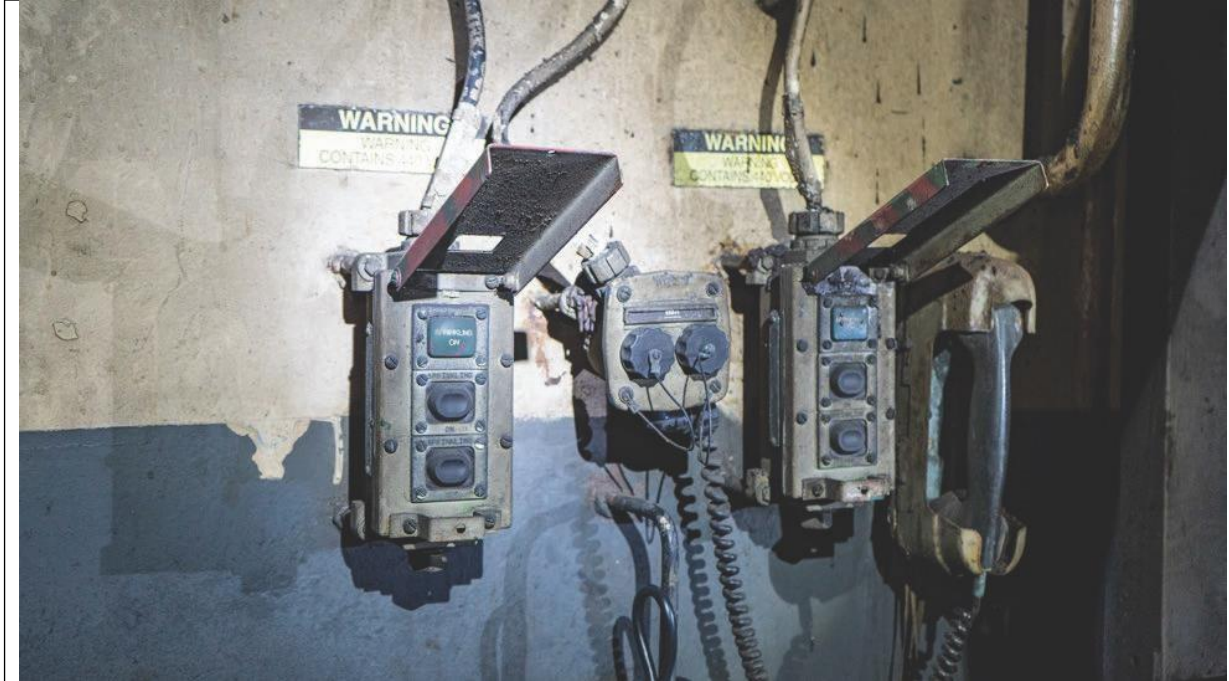
⁸⁰ Figure 32, Still photo of AFFF push-buttons for sprinkler groups 15 and 16 serving Lower V with covers open (16 on left; 15 on right). These push-buttons are in Upper V amidships

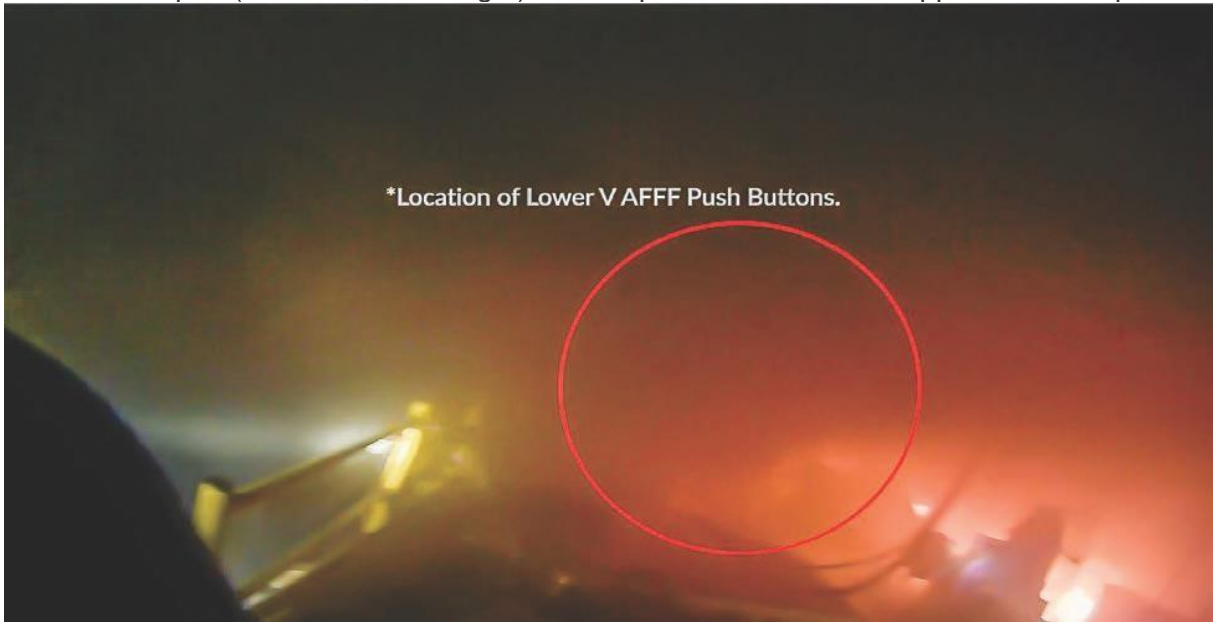
⁸¹ Figure 33, Still photo captured from GoPro video provided by San Diego Fire Department (SDFD) showing the location of AFFF push-buttons on 12 July 2020 after SDFD made entry into the vehicle stowage area via the sideport.
