İMA AKADEMİ YAYINLARI NU.3

12 Temmuz 2020 tarihinde USS BONHOMME RICHARD (LHD – 6)'da meydana gelen yangında Sabit AFFF sisteminin incelenmesi

USS Navy'nin 12 Eylül 2021 tarihli "COMMAND INVESTIGATION INTO THE FACTS AND CIRCUMSTANCES SURROUNDING THE FIRE ONBOARD USS BONHOMME RICHARD (LHD 6) ON OR ABOUT 12 JULY 2020" adlı raporu

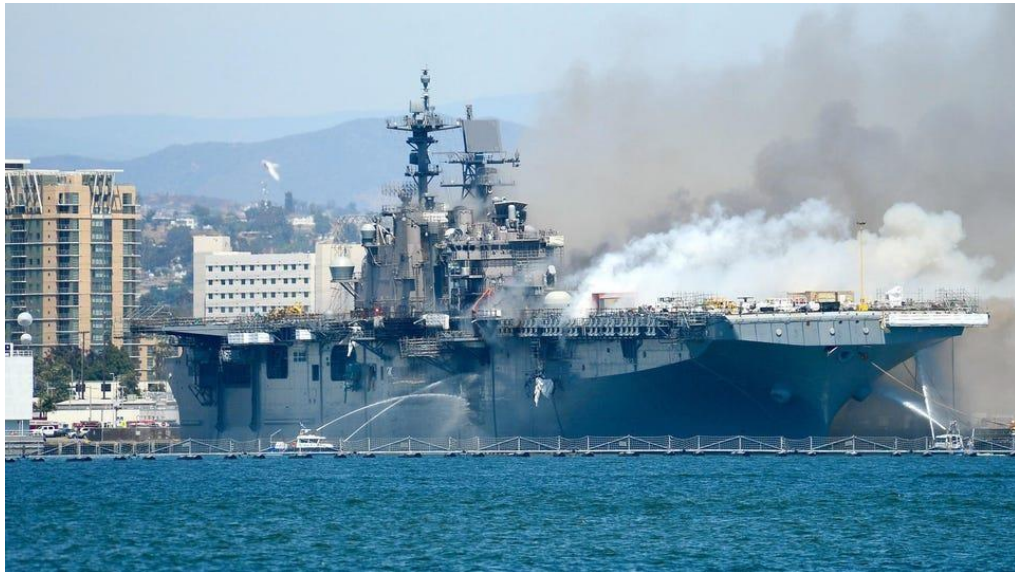
12 Temmuz 2020 Pazar günü San Diego Deniz Üssü'nde bir yangın USS BONHOMME RICHARD'ı (LHD 6) yoketti. Yangın yaklaşık beş gün boyunca sürdü. Yangın, geminin 14 güvertesinin 11'ine yayıldı ve 760 °C dereceyi aşan sıcaklıklara ulaştı. Yaklaşık 3 milyar dolar değerindeki USS BONHOMME RICHARD (LHD 6) yangın nedeniyle hizmet dışına ayrıldı.

Resim – 1 USS BONHOMME RICHARD (LHD 6) Yangını

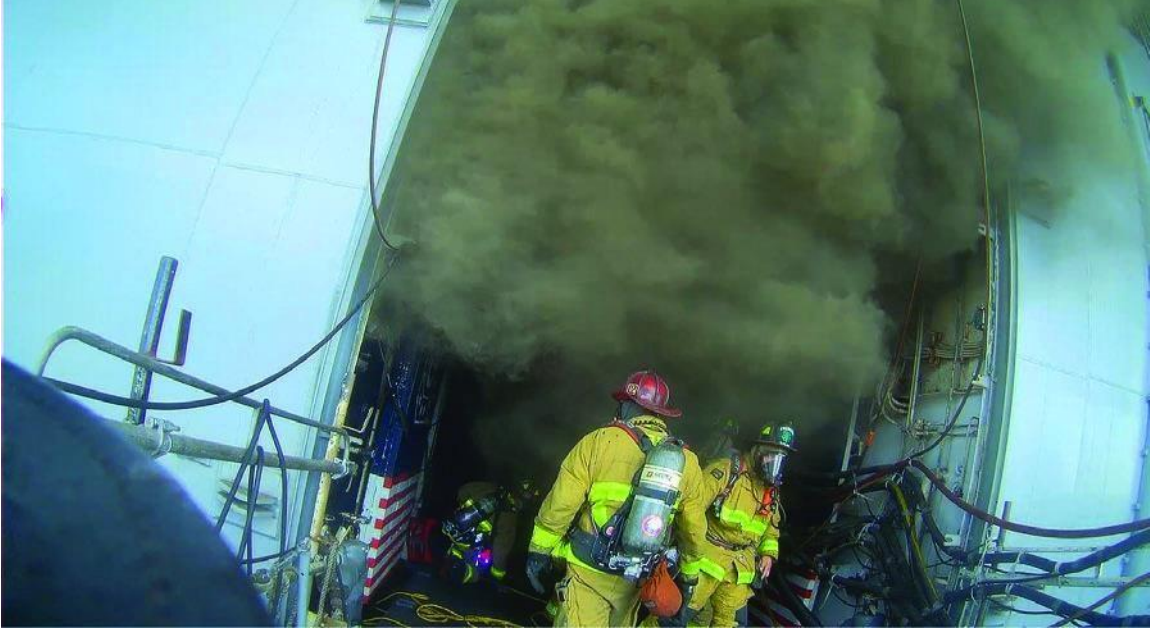
Resim – 2 USS BONHOMME RICHARD (LHD 6) Yangına Müdahale

- Yaklaşık 1715'te, AFFF'yi harici kullanma yöntemine karar verildi. ; Özellikle, geminin iskele tarafında ve Uçuş Güvertesinde birkaç delik açarak; daha sonra AFFF'yi bu deliklerden etkilenen bölgelere dağıtarak AFFF'nin kullanımı planlandı. . Bu maksatla , Uçuş Güvertesi üzerinden erişim için yüksek sıcaklık alanlarını belirlemek için termal görüntüleme ile donatılmış bir drone kullanıldı. AFFF ile müdahale harici bir yangın tulumbasından faydalanılarak gerçekleştirildi. Aşağıdaki alanların üzerinde Donanma PECU (Portable Exothermic Cutting Unit)'ları ile delikler açıldı: Müşterek İstihbarat Merkezi (02-81-0-C), Telsiz (02-85-01-C), İkmal Subayı Ofisi (JIQ) (02-113-1 -Q) ve II. Komutan Ofisi (02-118-0-Q). İlk gövde kesimi 1753'te tamamlandı ve AFFF ile , 1755'te Kemere 20'de 01-güverte seviyesinden kesilen yerlerden inline idaktör aracılığı ile harici müdahaleye başlandı.⁹
